# UNDERWATER BRIDGE INSPECTION REPORT

STRUCTURE NO. 6646

RED RIVER OF THE NORTH

MINNESOTA DEPARTMENT OF TRANSPORTATION  
UNDERWATER BRIDGE INSPECTION

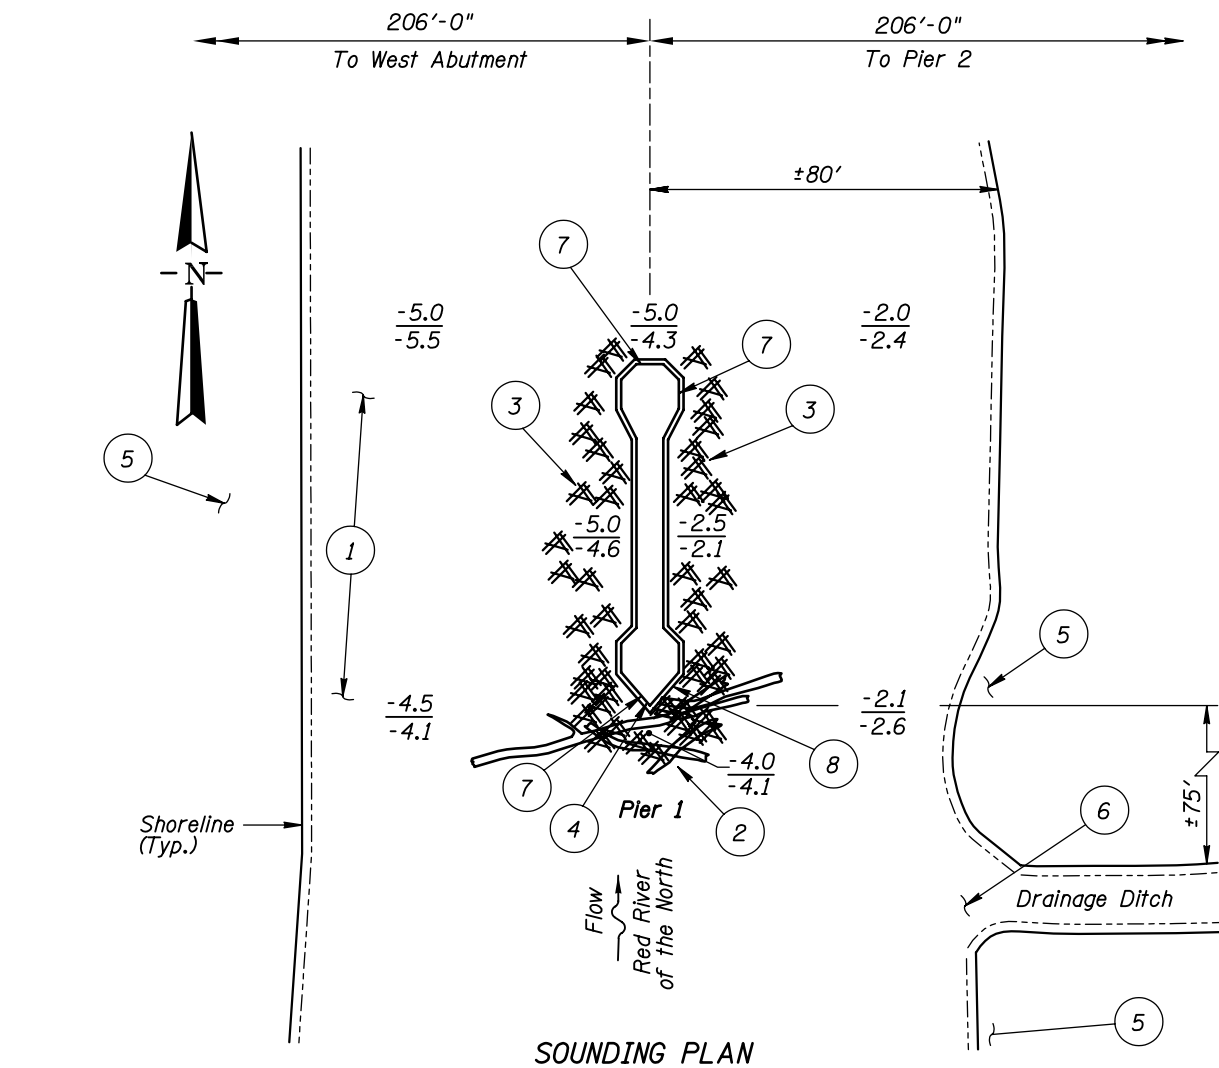
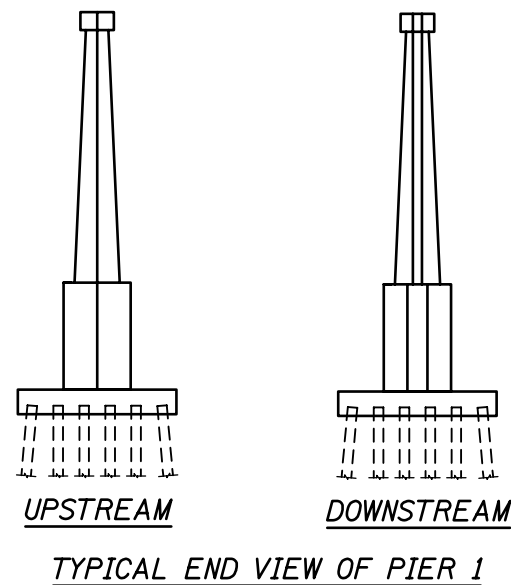
#### INSPECTION AND SOUNDING PLAN

- The channel bottom consisted of gravel with 2 inch diameter cobbles with up to 6 inches of probe rod penetration.
- A heavy accumulation of timber debris, consisting of logs up to 2 feet in diameter, was observed at the upstream end of the pier extending from the channel bottom to 6 feet above the waterline and 20 feet into the adjoining spans.

- A moderate accumulation of timber debris was observed along both faces of the pier and extended from the channel bottom to the waterline.
- The steel icebreaker angle exhibited 1/2-inch-diameter rust nodules with moderate pitting up to 1/4 inch deep.

- Both embankments exhibited heavy erosion upstream and downstream of the structure with a 4 foot vertical cut.
- The concrete erosion mat has failed along the last 200 feet of the drainage ditch.

- The cold joint at the top of the ledge in the pier shaft exhibited areas of section loss at the upstream and downstream noses up to 3 inches high with up to 1.5 inches of penetration.

- An area of section loss extended 6 inches above and 6 inches below the ledge at the upstream end of the pier with up to 6 inches of penetration but no reinforcing was observed.

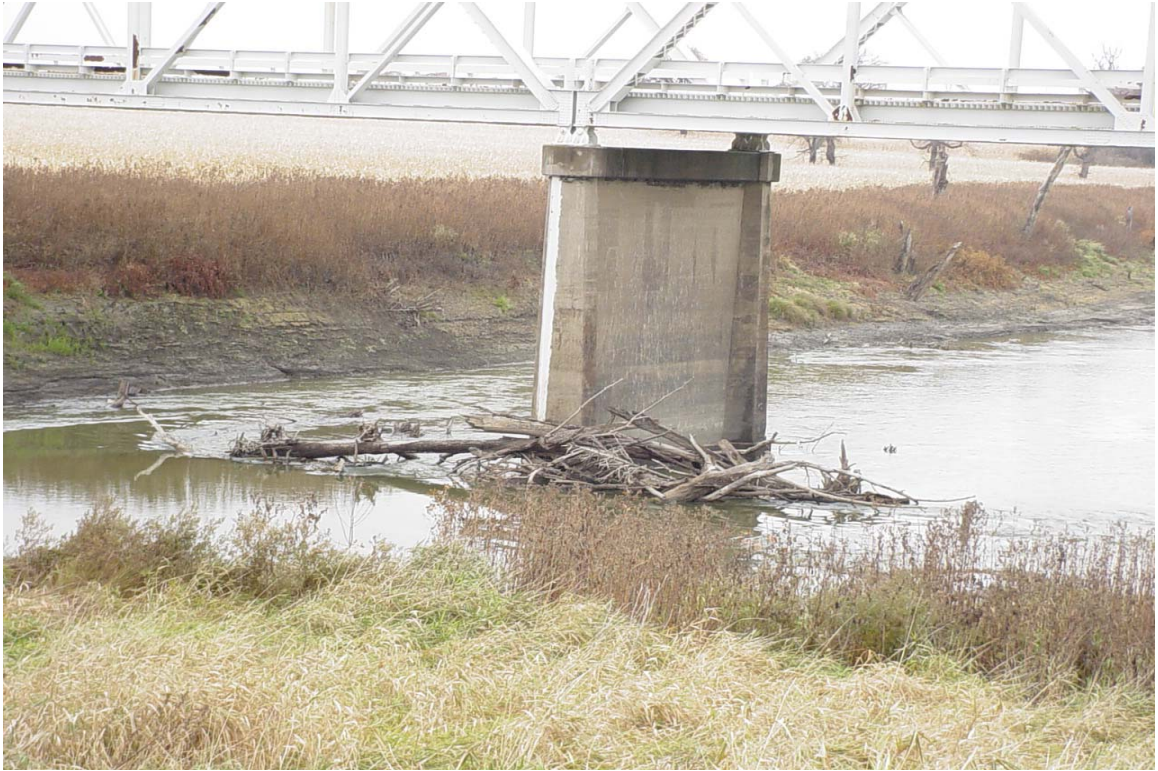
- (C) The cold joint at the top of the ledge in the pier shaft exhibited areas of section loss at the upstream and downstream noses up to 3 inches high with up to 1.5 inches of penetration. An additional area of section loss at the upstream end of the pier extended 6 inches above and 6 inches below the ledge with up to 6 inches of penetration but no reinforcing steel was exposed.

Photograph 1. View of Pier 1, Looking Northwest.

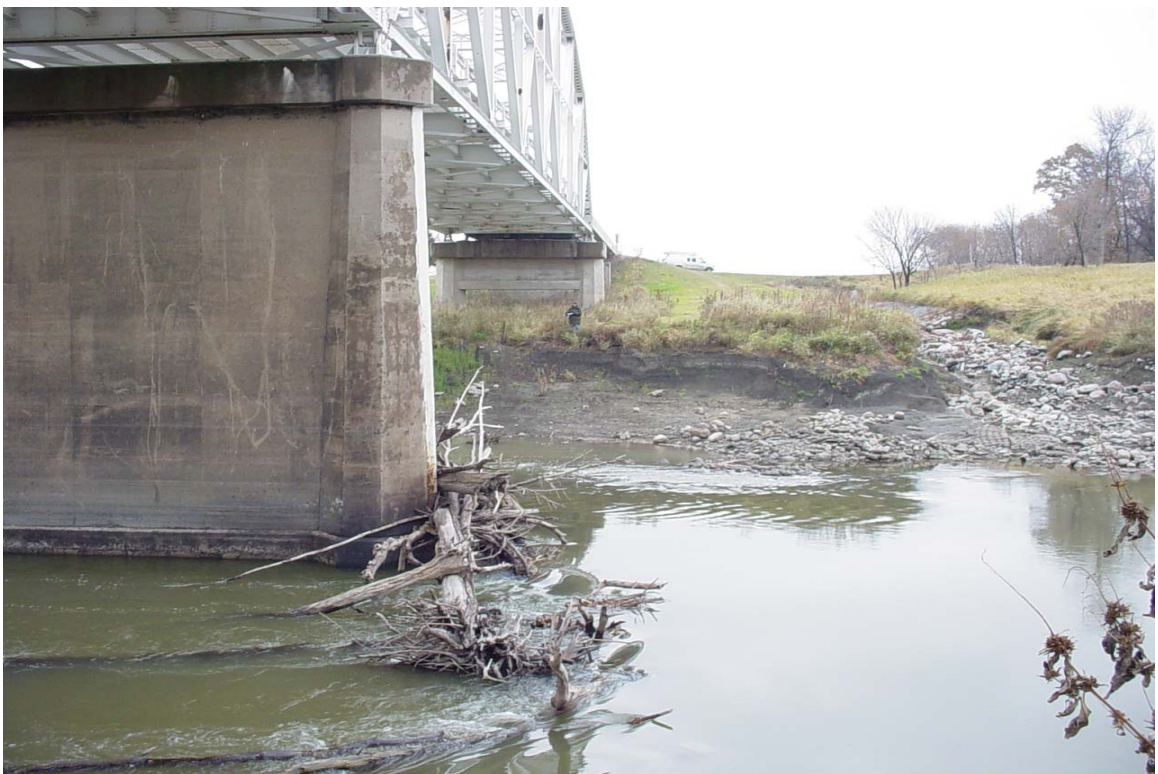
- (A) A heavy accumulation of timber debris, consisting of logs up to 2 foot in diameter, was observed at the upstream end of the pier extending from the channel bottom to 6 feet above the waterline and 20 feet into the adjoining spans. A moderate accumulation of timber debris was also observed along both faces of the pier and extended from the channel bottom to the waterline.

- (D) Both embankments were heavily eroded upstream and downstream of the structure with a typical vertical drop off of 4 feet to the waterline. In addition, the concrete erosion mat has failed along the last 200 feet of the drainage ditch upstream of the structure.

Photograph 2. View of Timber Debris and Drainage Ditch, Looking East.

- (A) Monitor river embankment erosion during future biennial inspections. Investigate flow and erosion conditions around the bridge and through the upstream ditch and address the erosion protection needs for site specific conditions.
- (B) Remove the heavy accumulation of timber debris from the upstream end and along the sides of Pier 1 to alleviate further accumulations and scour problems.
- (C) Reinspect the submerged substructure unit at the normal maximum recommended (NBIS) interval of five (5) years.
